KAMEHAMEHA SCHOOLS LARGE CAPACITY CESSPOOL AUDIT

KAUAI, MAUI, AND MOLOKAI, HAWAII FEBRUARY 2022

R. M. TOWILL CORPORATION

LARGE CAPACITY CESSPOOL AUDIT INSPECTION PHASE COMPLETION REPORT – PHASE 2

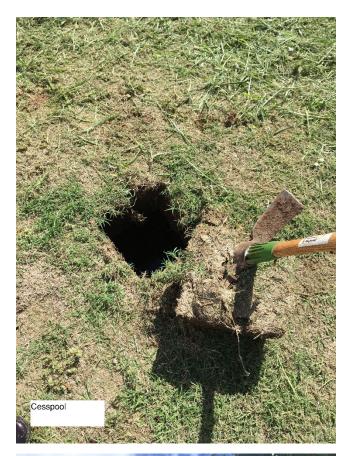
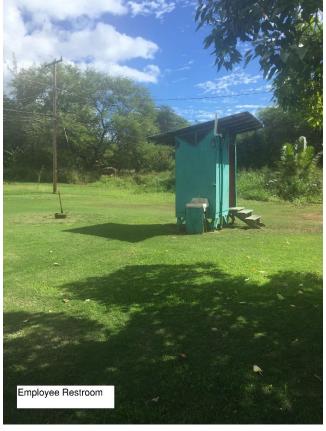
Inspection Report – LCC 1

| Site TMK | 256006008 |
|---|--|
| LCC Determination and Reasoning | During the site visit, RMTC observed a Native Hawaiian fishpond operation. RMTC interviewed the tenant. Tenant confirmed there is a single restroom onsite connected to a cesspool. The tenant stated that the restroom is only available to employees, of which there are a maximum of 5. The only visitors to the site are educational groups. When the groups visit the site, the groups are required to bring in portapotties. RMTC observed the single restroom connected to a cesspool during the site visit. The restroom is an outhouse located in an area easily accessed by any visitors to the site. In the time since the initial site visit, two incinerator toilets have been installed on the property. These restrooms are used by visitors to the property, however the outhouse has not been demolished and can still be used by 20 persons per day. This is a Large Capacity Cesspool (LCC) because the cesspool has the potential to serve more than 19 people in a 24-hour period. |
| Description of LCC | This is a cesspool on commercial property that may serve 20 or more people in a 24-hour period. |

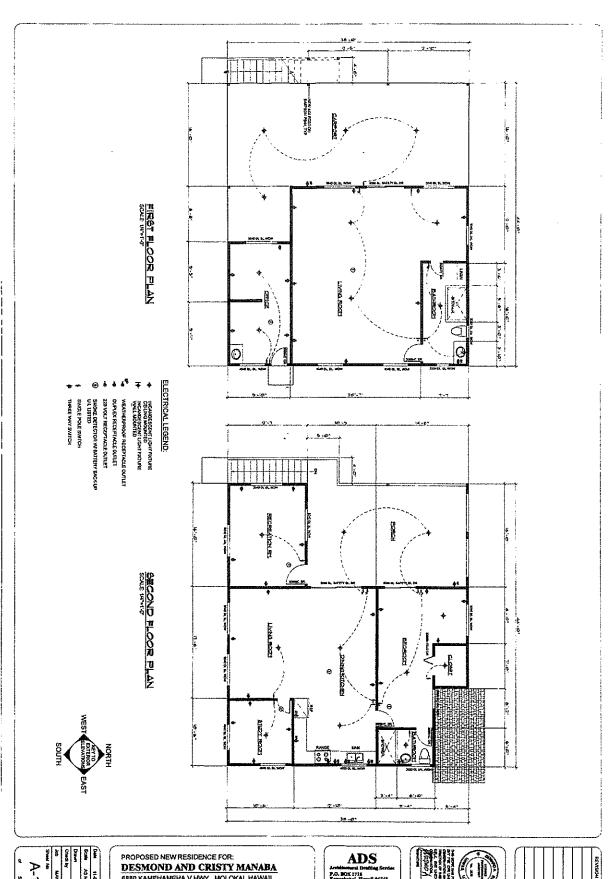
INDIVIDUAL WASTEWATER DESIGN FOR: KEAWA NUI FARM TMK: (2) 5-6-006:034 March 19, 2014 DWELLING DWELLING

EXISTING CESSPOOL TO BE ABANDONED: PUMP,
BACKFILL, REROUTE SEWER LINE TO AEROBIC TANK.
CONTRACTOR TO LOCATE CESSPOOL & NOTE SIZE
ON ASBUILT FOR ENGINEER. SEE NOTES
BOLLARDS: TO PROTECT TANK

1000 GALLON (MIN) AEROBIC TANK:

JENSEN PRECAST HJ1500 OR EQUAL.

1000 SF: 22' WIDE X 50' LONG *
32 H-20 INFILTRATORS TOTAL,
4-ROWS OF CHAMBERS, 5' O.C.,
2' FROM SIDEWALLS ON 6" GRAVEL BED,
BACKFILLED WITH GRAVEL & CONTINUOUS
FILTER FABRIC. (SEE DETAILS)

CESSPOOL ABANDONMENT NOTES:

The Contractor shall abandon the cesspool by first removing any excess liquid and solids by pumping and then filling the cesspool with earth, sand, gravel, concrete or rubble. if the cover is removed, the final three(3) feet of fill shall be with solid that is compacted to prevent surface contaminants from gaining access to underground sources of water. Any liquids or solids removed from the cesspool shall be taken to a municipal wastewater treatment plant that accepts such materials. Any liquid or solids from the cesspool that are discharged onto the ground as the result of abandoning the cesspool is a violation of HAR, section 11-62-06(g).

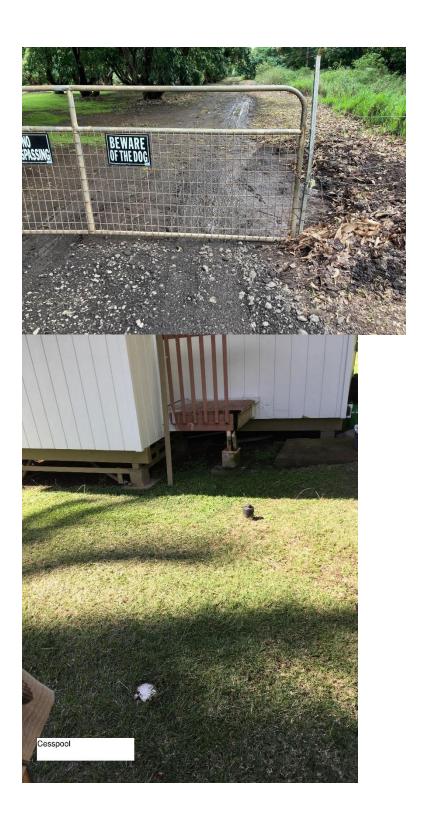
| Site TMK | 257008004 | |
|---|---|--|
| | During the site visit, RMTC observed a mango farm and a single-family home on the property. RMTC interviewed the tenant. Tenant confirmed the only structure with a bathroom facility is the single-family home in which no one lives. The single-family home is connected to a cesspool. RMTC confirmed with the tenant the general location of the cesspool. RMTC observed a sewer cleanout and cesspool inspection port cap. | |
| | This is a Small Capacity Cesspool (SCC) because it is non-residential with the capacity to serve fewer than 20 persons a day. | |
